Confidential Inspection Report

**John Doe
1234 Spruce
Cleveland, Ohio, 44411**

**Affordable Inspection Service, LLC
PO Box 45580
Cleveland, Ohio 44145-9998
216-341-0601**

August 13, 2018

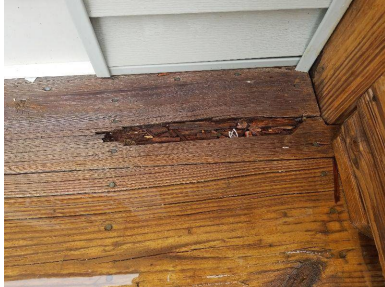
Wood rot was observed. Do not use balcony until repairs have been made. We recommend replacing the

damaged materials.

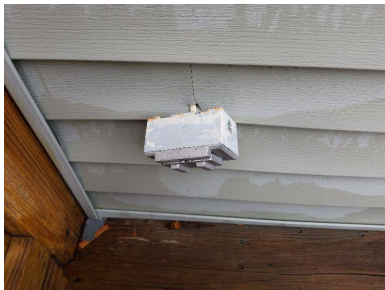
Loose electrical receptacle(s) were noted. We recommend repairing all loose receptacles.

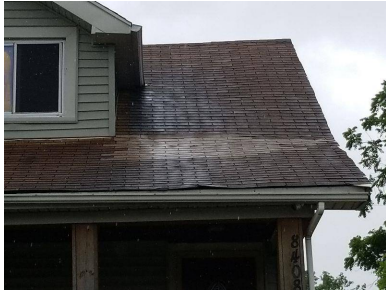
Roofing material is cracked and curling. Although this is a natural condition brought on by exposure to the ultraviolet light and the elements, we recommend budgeting for repair / replacement of the roof covering.

Missing roofing materials. We recommend replacement of the missing roofing materials.

Roofing material is worn. We recommend budgeting for repair / replacement of the roof covering. A roof tune-up may extend the life of the roof.

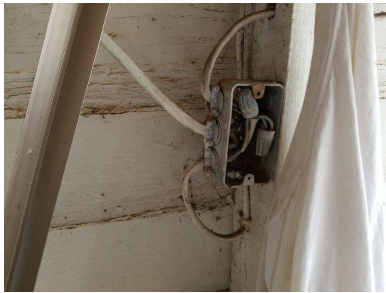
Junction box(es) are missing cover(s). We recommend installing cover(s) where needed.

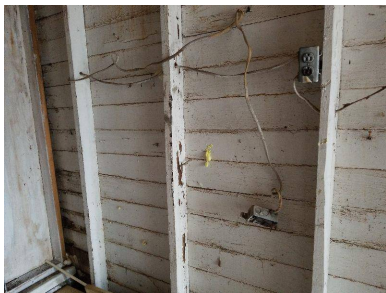
Branch wiring is loose. We recommend re-attaching the wiring to the joists / studs with proper staples / clips.

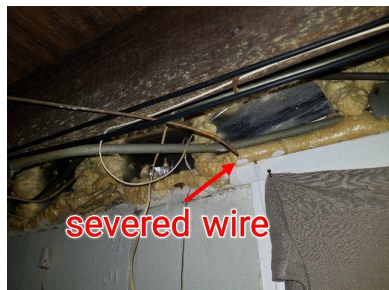
Ground wire has been severed causing the electrical system to be ungrounded. We recommend replacing the ground wire with a continuous wire from the neutral buss bar to the point of grounding.

We recommend the installation of a jumper wire across the water meter to ensure adequate grounding.

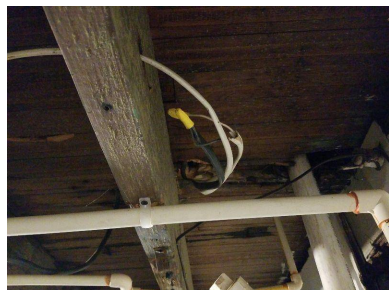
Substandard (handyman) wiring and connections are installed in a haphazard manner. There is an increased potential for shock and fire hazards. Every instance of handyman wiring present may not be detailed in this report. We recommend further evaluation and repair by a qualified electrician.

Open splices are present. We recommend placing all splices in a covered junction box.

Branch wiring is loose. We recommend re-attaching the wiring to the joists / studs with proper staples / clips.

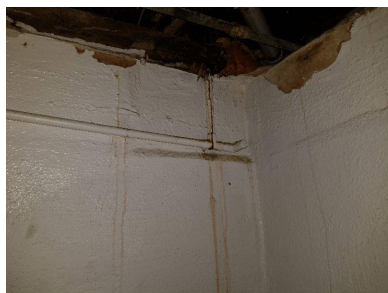
Water supply piping leaking at the fittings. We recommend repairing / replacing all leaking fittings.

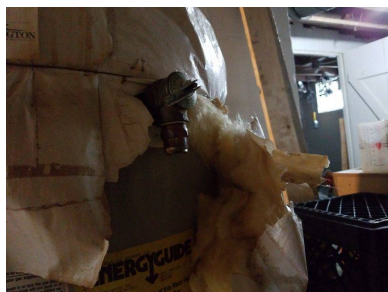
Water heater pressure relief valve (PRV) extension pipe is missing. We recommend installing a 3/4 " copper pipe that extends within 6" of the floor.

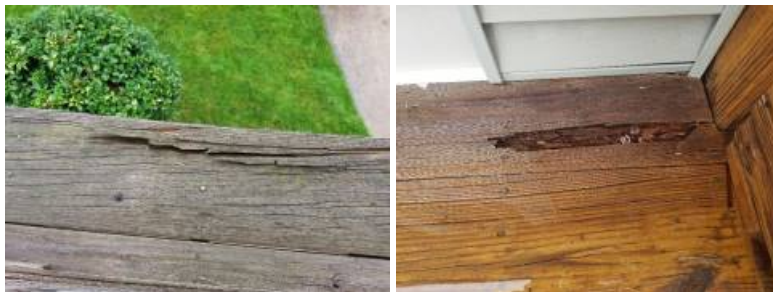
Damage was noted. Do not use balcony until repairs have been made. We recommend making the necessary repairs.

Wood rot was observed. Do not use balcony until repairs have been made. We recommend replacing the damaged materials.

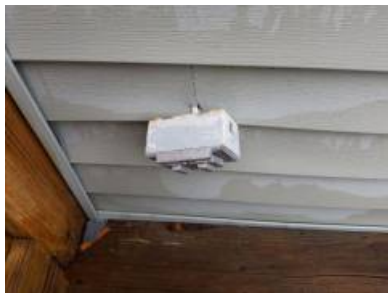
Loose electrical receptacle(s) were noted. We recommend repairing all loose receptacles.

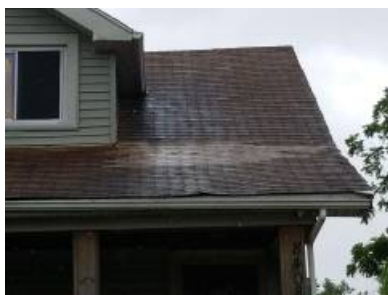
CONDITION: Roofing material is cracked and curling. Although this is a natural condition brought on by exposure to the ultraviolet light and the elements, we recommend budgeting for repair / replacement of the roof covering. Missing roofing materials. We recommend replacement of the missing roofing materials. Roofing material is worn. We recommend budgeting for repair / replacement of the roof covering. A roof tune-up may extend the life of the roof.

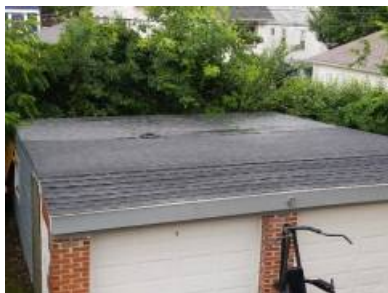
CONDITION: Portions / Entire roof is considered to have a low slope. This makes it susceptible to leakage during winter weather and high wind. We recommend replacing the shingles with a more water tight material to reduce the risk of water damage.

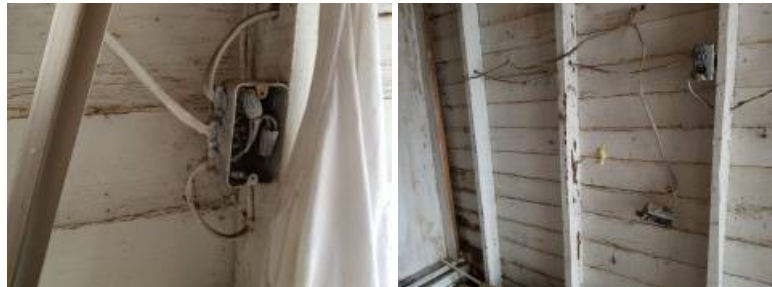
CONDITION: Junction box(es) are missing cover(s). We recommend installing cover(s) where needed.

Branch wiring is loose. We recommend re-attaching the wiring to the joists / studs with proper staples / clips.

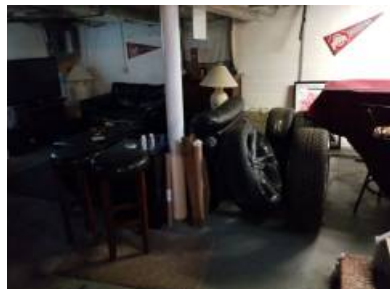
Visual inspection of the basement is limited due to extensive storage.

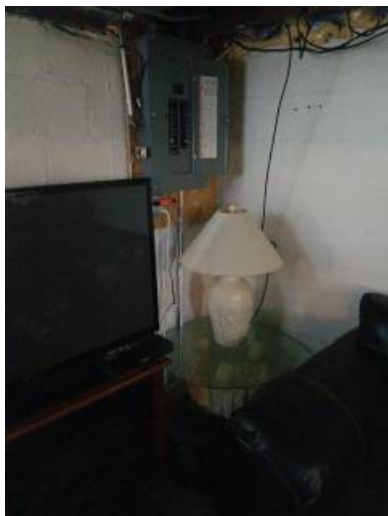
CONDITION: Access to the panel interior was blocked by wall coverings, storage or cabinetry. No inspection was made of the interior of the main electrical panel. We recommend having the homeowner provide access and call for a re-inspection. A re-inspection fee of \$75 will apply.

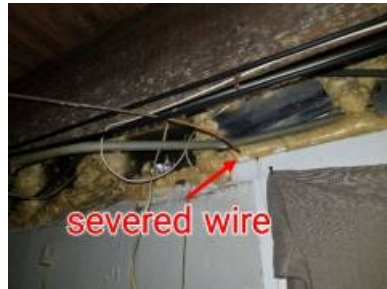
DESCRIPTION: Ground wire has been severed causing the electrical system to be ungrounded. We recommend replacing the ground wire with a continuous wire from the neutral buss bar to the point of grounding. We recommend the installation of a jumper wire across the water meter to ensure adequate grounding.

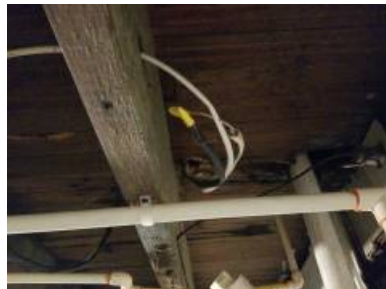
Substandard (handyman) wiring and connections are installed in a haphazard manner. There is an increased potential for shock and fire hazards. Every instance of handyman wiring present may not be detailed in this report. We recommend further evaluation and repair by a qualified electrician.

Open splices are present. We recommend placing all splices in a covered junction box.

Branch wiring is loose. We recommend re-attaching the wiring to the joists / studs with proper staples / clips.

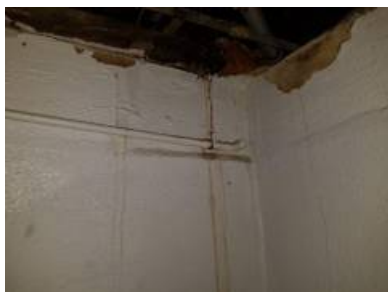
CONDITION: Water supply piping leaking at the fittings. We recommend repairing / replacing all leaking fittings.

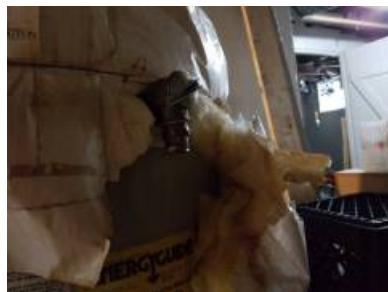
PRESSURE RELIEF VALVE: Water heater pressure relief valve (PRV) extension pipe is missing. We recommend installing a 3/4 " copper pipe that extends within 6" of the floor.

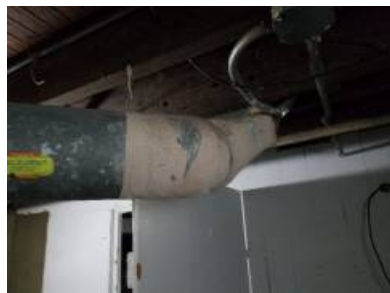
Asbestos was a common insulating wrap used in many homes. Left undisturbed the wrap does not possess any significant health threat. However we do recommend having the Asbestos removed by a qualified asbestos remediation company.
