Confidential Inspection Report

Sample

5555 Forest

Affordable Inspection Service, LLC

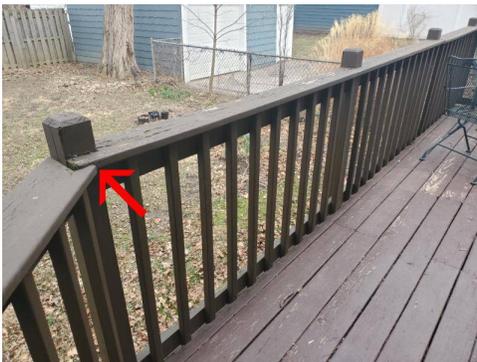
Railing is loose. Use extreme caution when using the deck. We recommend repairing the railing.

Peeling / Blistering paint was observed. We recommend scraping and repainting the affected surface(s).

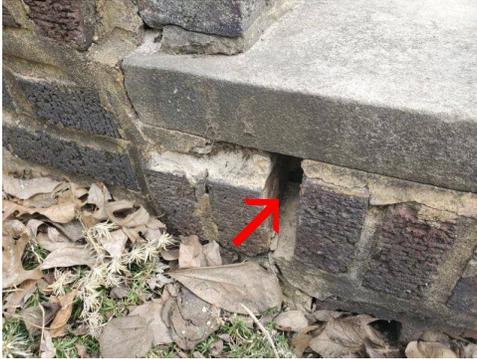
Railing is loose. Use extreme caution when using the front steps. We recommend repairing the railing.

Tuck Pointing of the mortar between the bricks at the front steps is needed.

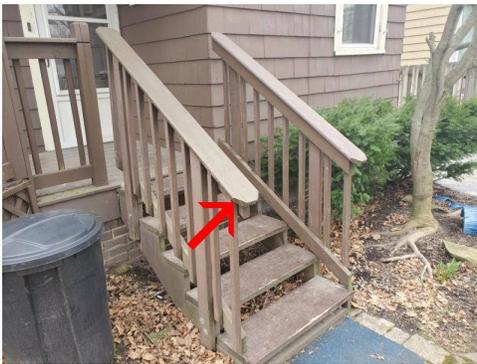
Railing is loose. Use extreme caution when using the rear / side steps. We recommend repairing the railing.

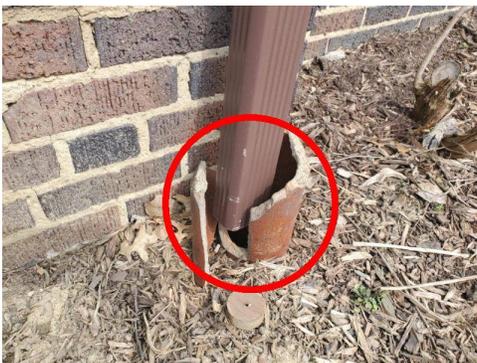
Storm drain is damaged / cracked where connection with the downspout is made. This may be symptomatic of a clogged drain as the pipe can become cracked when filled with freezing water. We recommend repair / replacement of the damaged pipe and ensuring the pipe drains freely.

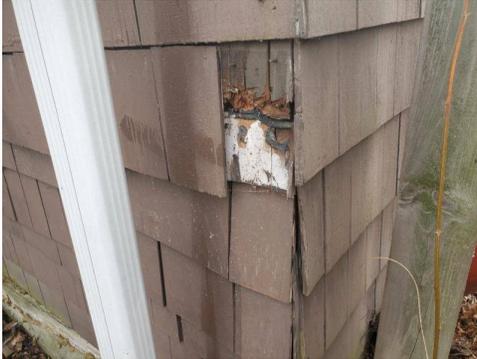
Wood rot was observed at the wood portion of the siding. We recommend replacing the damaged siding. Peeling / Blistering paint was observed. We recommend scraping and repainting the affected surface(s). Exterior wall covering(s) were observed to be missing. We recommend replacement of the missing wall covering material.

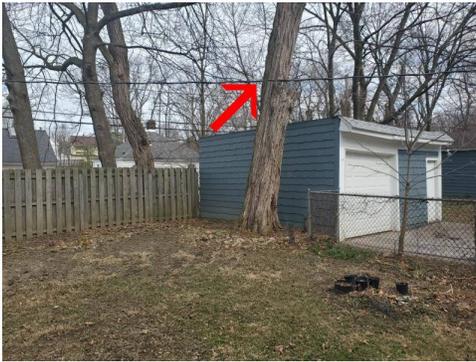
Service drop height is too close to the ground at the exterior of the building. Minimum height is 10' above the sidewalks and decks and 12' above the driveway. We recommend contacting the electrical service provider to arrange for the cable to be raised to a proper height.

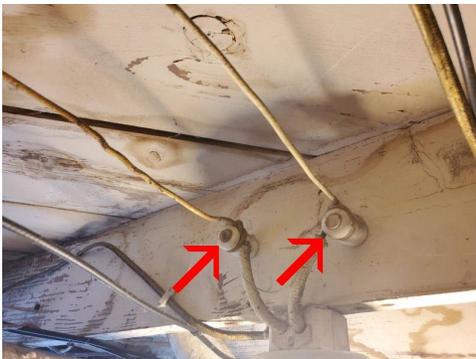
Knob & Tube branch wiring was observed. Knob and Tube wiring is an older method with no ground wire and should be replaced if the sheathing is observed to be deteriorating. Over the last several years, a number of insurance companies have declined to underwrite home insurance policies on older homes with knob and tube wiring. This obviously prevents most homeowners from proceeding with the purchase of a home with either of these features, as fire insurance is typically required to obtain a mortgage. While insurance companies may consider knob and tube wiring unsafe, this condition does not automatically present a significantly higher risk of fire or other insured loss than other systems - although reasonable concern is warranted. Insulation which is blown in, loose or comprised of expanding foam which surrounds the knob and tube wiring may not let the heat dissipate in the surrounding air and is prohibited by national standards. Knob and tube wiring which is buried in inaccessible places may be covered with insulation, but are excluded from this inspection due to the inaccessibility. We recommend further evaluation from a qualified electrician.

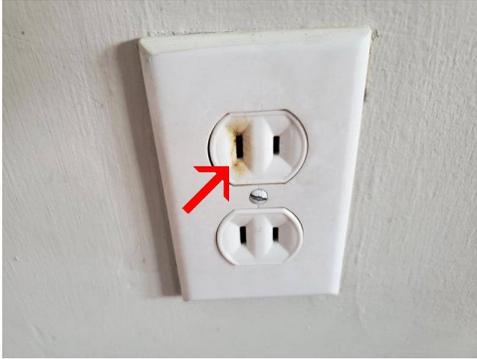
Scorched electrical receptacle(s) were noted. We recommend further evaluation by a qualified electrician.

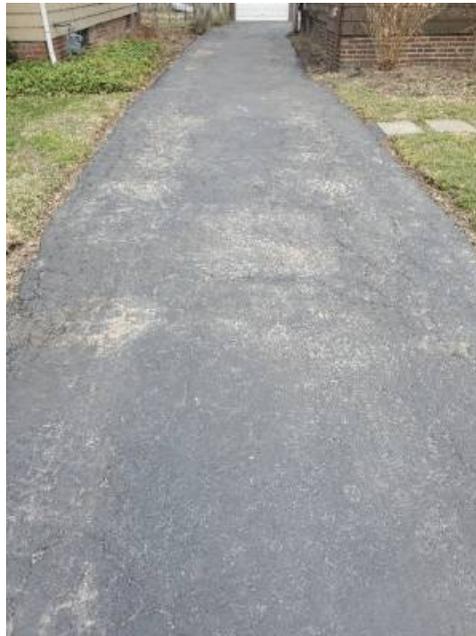
Driveway has minor settling / shrinkage cracks which may develop into larger cracks during the expansion and contraction of the freeze cycles. We recommend replacing the damaged slabs if they become a trip hazard. Patching of the damaged slabs is not recommended as this is rarely effective and seldom holds beyond the first winter freeze.

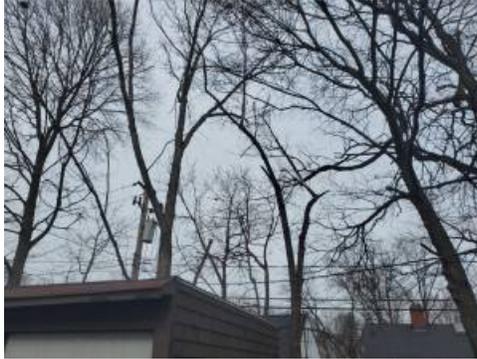
Limbs are overhanging the structure. Falling limbs can cause injury and damage. We recommend consulting with a qualified tree surgeon to determine if limbs need to be removed.

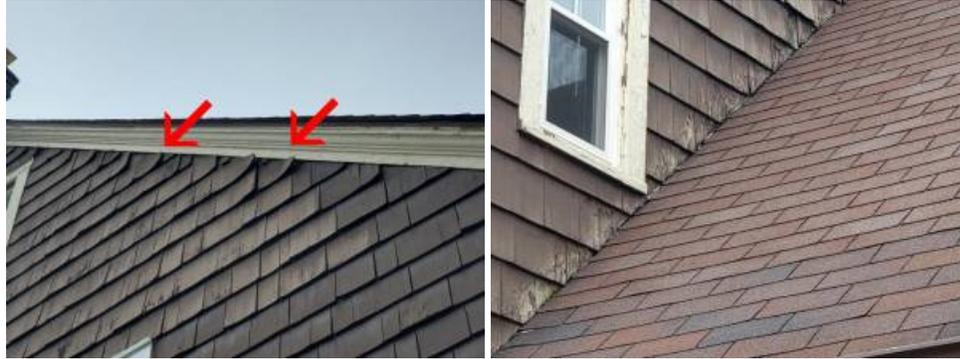
Wood curling was noted. We recommend making the necessary repairs.
Peeling / Blistering paint was observed. We recommend scraping and repainting the affected surface(s).

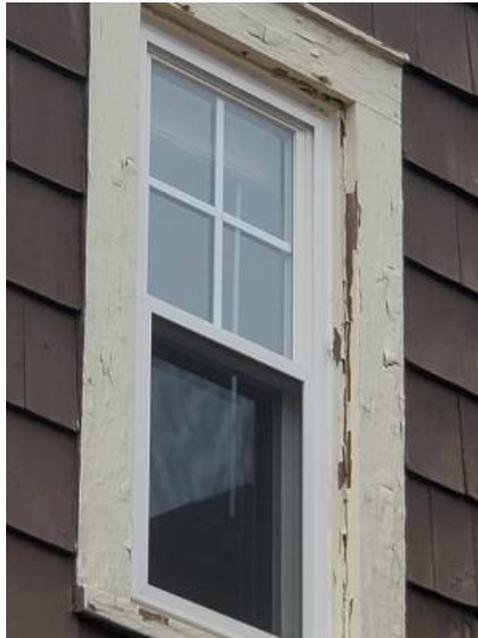
Peeling / Blistering paint was observed. We recommend scraping and repainting the affected surface(s).

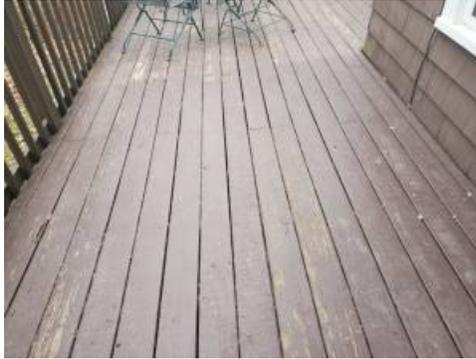
Peeling / Blistering paint was observed. We recommend scraping and repainting the affected surface(s).

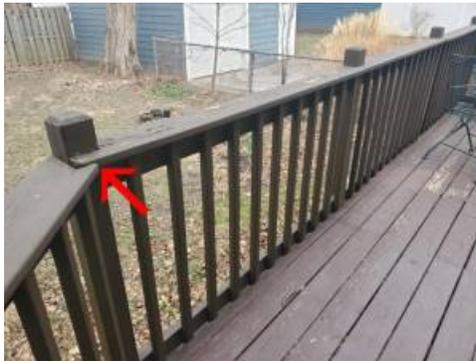
Deck railing is constructed partially / entirely of wood. Railing is loose. Use extreme caution when using the deck. We recommend repairing the railing. Peeling / Blistering paint was observed. We recommend scraping and repainting the affected surface(s).

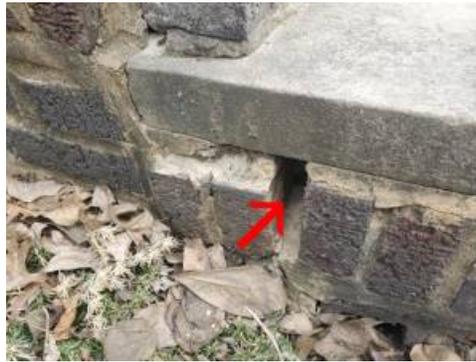
Railing is loose. Use extreme caution when using the front steps. We recommend repairing the railing. Tuck Pointing of the mortar between the bricks at the front steps is needed.

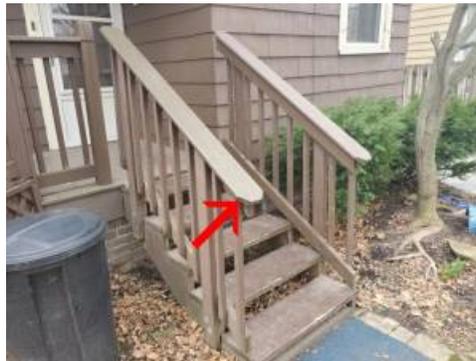
Railing is loose. Use extreme caution when using the rear / side steps. We recommend repairing the railing.

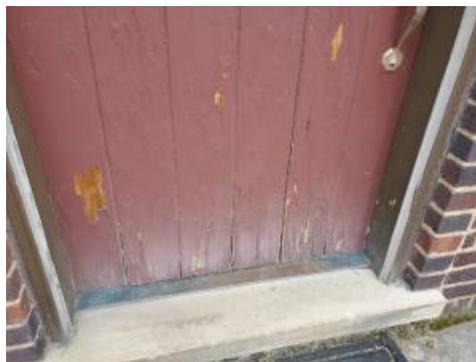
Peeling / Blistering paint was observed at the exterior doors. We recommend scraping and repainting the affected surface(s).

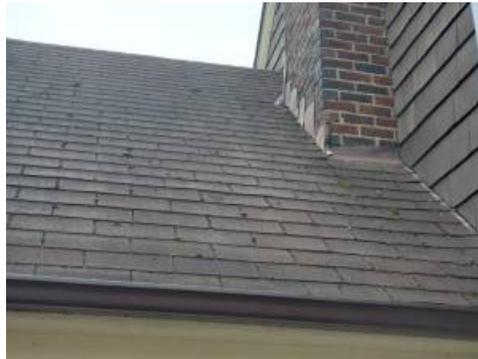
CONDITION: Moss growing on roof. We recommend gently removing the moss with a mild solution of bleach and water. A roof tune-up may extend the life of the roof.

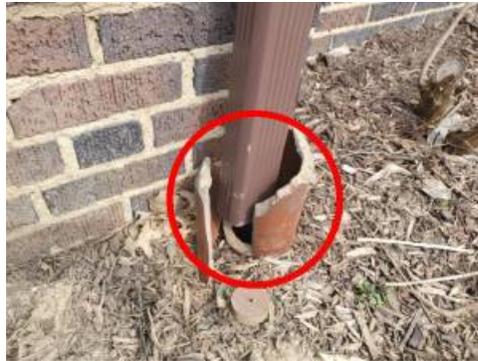
Storm drain is damaged / cracked where connection with the downspout is made. This may be symptomatic of a clogged drain as the pipe can become cracked when filled with freezing water. We recommend repair / replacement of the damaged pipe and ensuring the pipe drains freely.

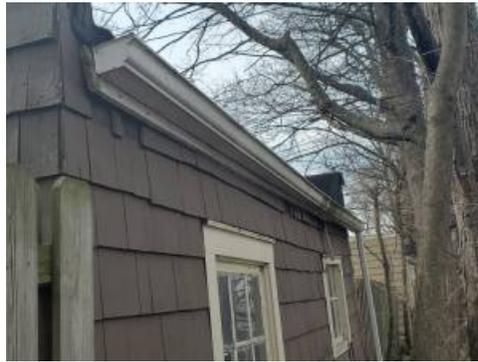
CONDITION: Gutters have inadequate pitch. We recommend re-installing the gutters to provide for drainage toward the downspout.

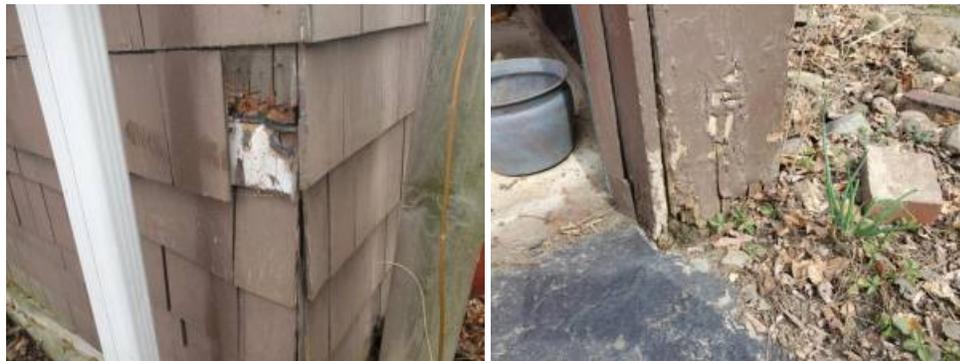
Wood rot was observed at the wood portion of the siding. We recommend replacing the damaged siding. Peeling / Blistering paint was observed. We recommend scraping and repainting the affected surface(s). Exterior wall covering(s) were observed to be missing. We recommend replacement of the missing wall covering material.

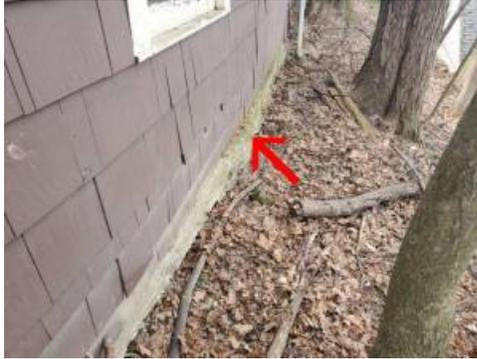
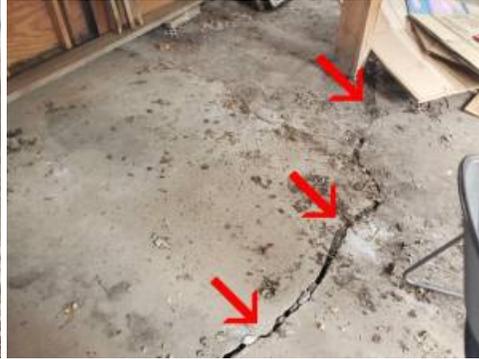
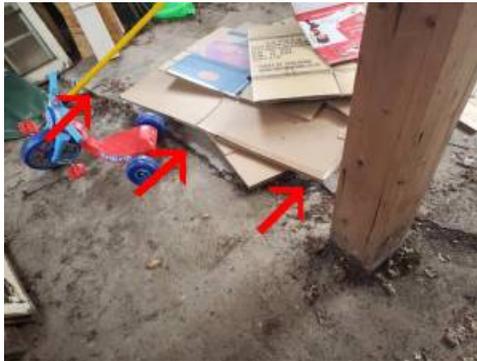
Garage floor has major settling cracks. We recommend further evaluation and repair by a qualified contractor.

Garage floor is settling unevenly, which may be a trip hazard. Use caution when using the garage. We recommend consulting with a qualified contractor to determine the most cost-effective repair.

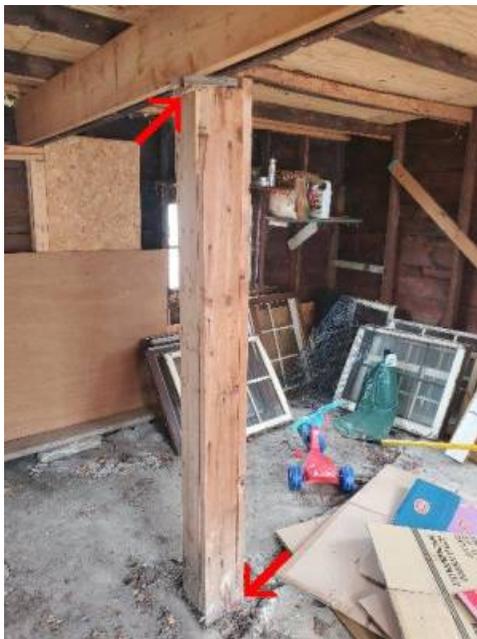
Repair work done to the garage is of poor quality. It is important to remember that the garage is not considered a living space and is typically not finished with the same attention to detail as the main house. With that in mind, we recommend further repair if the condition of garage is a source of discomfort.

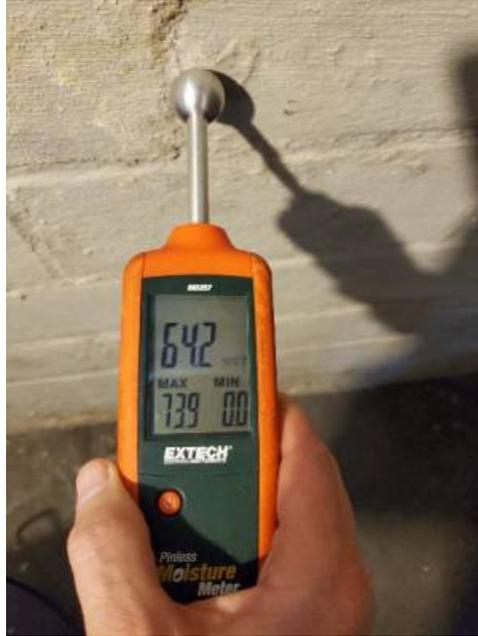
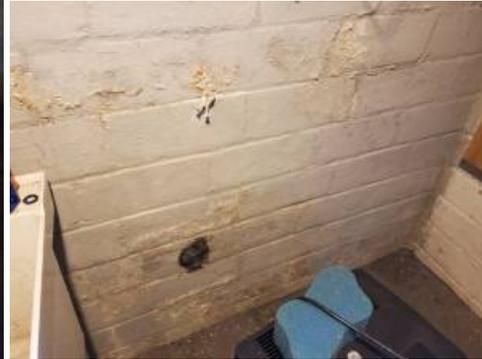
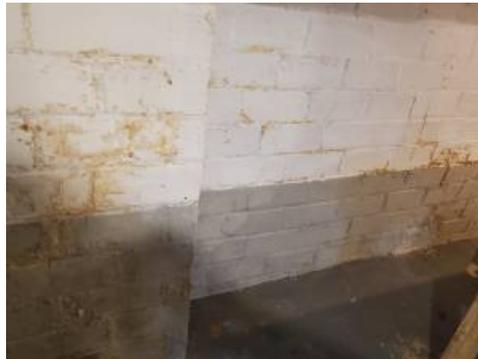
CONDITION: By using a moisture meter elevated moisture readings were found along the basement walls. This is a positive indication that there is some moisture intrusion into the basement. The amount of moisture may vary from season to season. We recommend further evaluation by a qualified waterproofing contractor if any problems persist. The use of a De-Humidifier may aid in the removal of moisture.

Efflorescence was observed. This is caused by moisture evaporating inside the basement. We recommend the use of a basement De-humidifier, if the problem persists then further evaluation by a qualified waterproofing contractor is recommended.

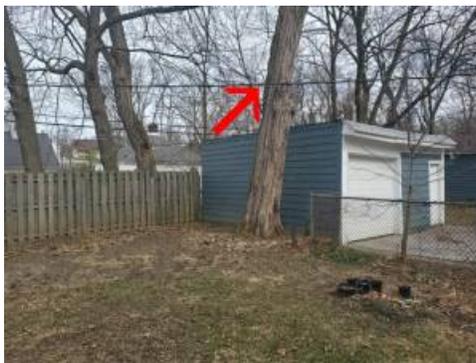
Service drop height is too close to the ground at the exterior of the building. Minimum height is 10' above the sidewalks and decks and 12' above the driveway. We recommend contacting the electrical service provider to arrange for the cable to be raised to a proper height.

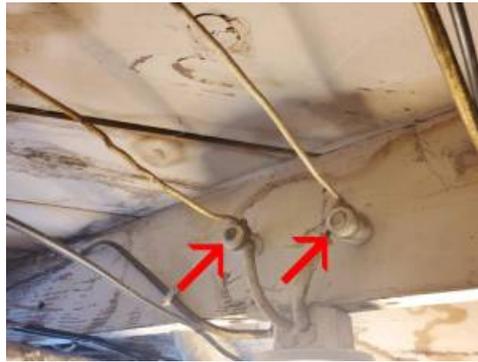
Knob & Tube branch wiring was observed. Knob and Tube wiring is an older method with no ground wire and should be replaced if the sheathing is observed to be deteriorating. Over the last several years, a number of insurance companies have declined to underwrite home insurance policies on older homes with knob and tube wiring. This obviously prevents most homeowners from proceeding with the purchase of a home with either of these features, as fire insurance is typically required to obtain a mortgage. While insurance companies may consider knob and tube wiring unsafe, this condition does not automatically present a significantly higher risk of fire or other insured loss than other systems - although reasonable concern is warranted. Insulation which is blown in, loose or comprised of expanding foam which surrounds the knob and tube wiring may not let the heat dissipate in the surrounding air and is prohibited by national standards. Knob and tube wiring which is buried in inaccessible places may be covered with insulation, but are excluded from this inspection due to the inaccessibility. We recommend further evaluation from a qualified electrician.

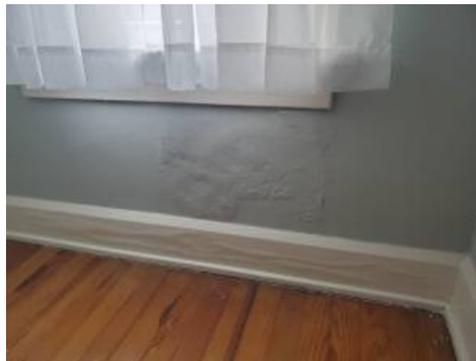
CONDITION: Interior walls were finished poorly / incompletely. We recommend repair of the effected areas.

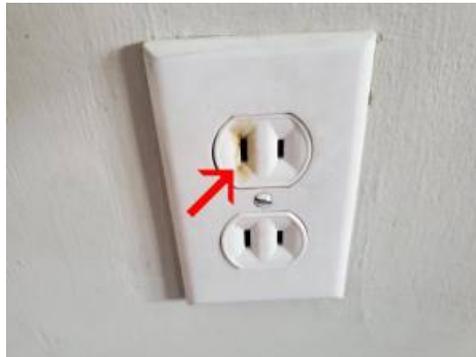
CONDITION: Scorched electrical receptacle(s) were noted. We recommend further evaluation by a qualified electrician.
