Confidential Inspection Report

Sample

5555 Forest

Affordable Inspection Service, LLC

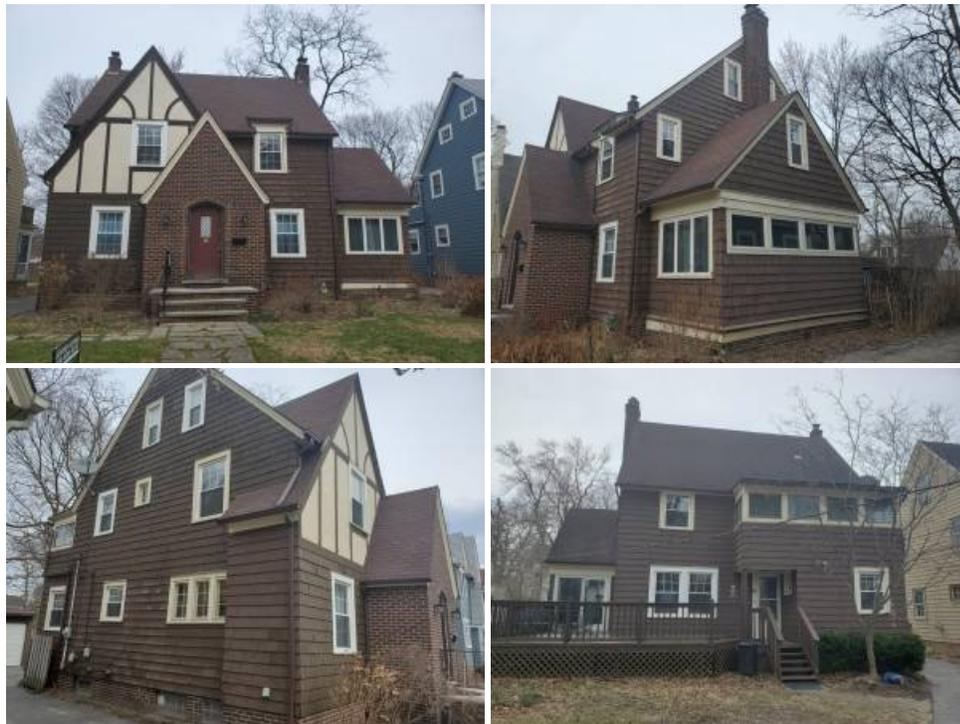
Wood curling was noted. We recommend making the necessary repairs.
Peeling / Blistering paint was observed. We recommend scraping and repainting the affected surface(s).

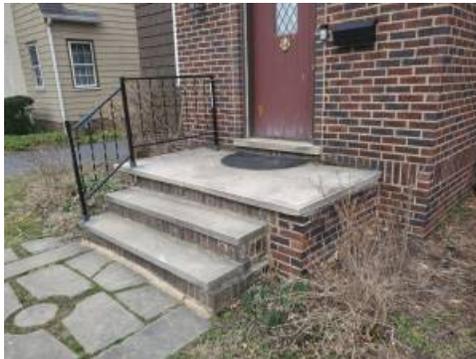
Railing is loose. Use extreme caution when using the front steps. We recommend repairing the railing. Tuck Pointing of the mortar between the bricks at the front steps is needed.

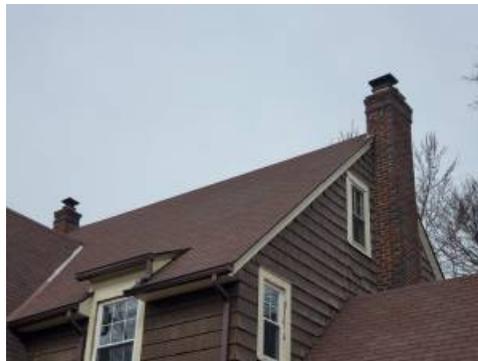
Chimney appears serviceable.

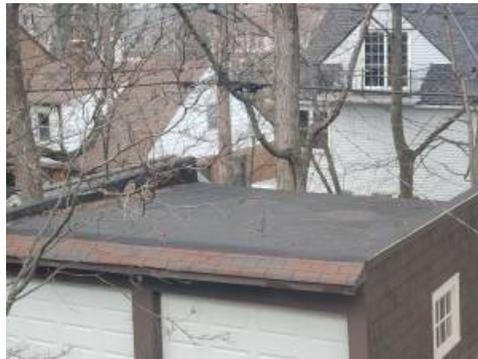
DESCRIPTION: Asphalt composite shingles are installed on the main roof. Asphalt shingles have an estimated life span of 15 - 20 years.
Asphalt roll roofing is installed on the main roof. Roll roofing has an estimated life span of 10 years.

CONDITION: Debris was found laying on the roof. We recommend having the debris carefully removed.

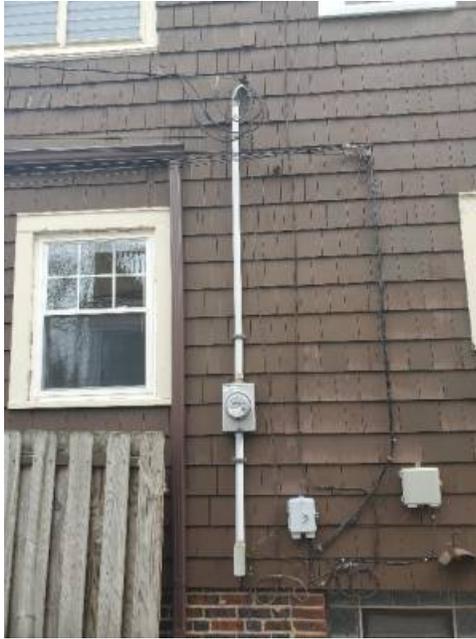
Aluminum service wires, Wires enter the house at a mast above the ground.

Service drop height is too close to the ground at the exterior of the building. Minimum height is 10' above the sidewalks and decks and 12' above the driveway. We recommend contacting the electrical service provider to arrange for the cable to be raised to a proper height.

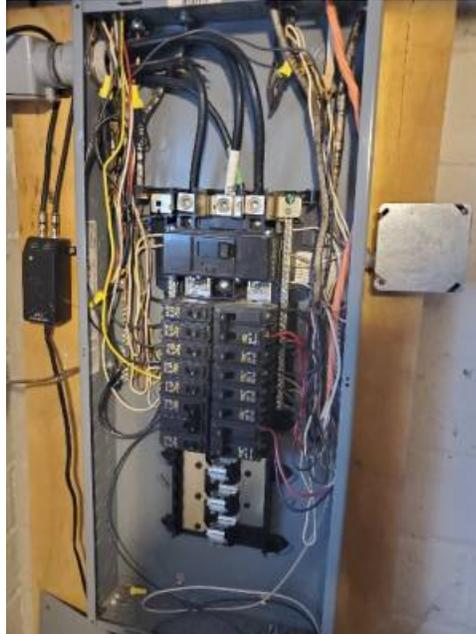
Main electrical panel is located in the basement.

CONDITION: Main electrical panel appears serviceable.

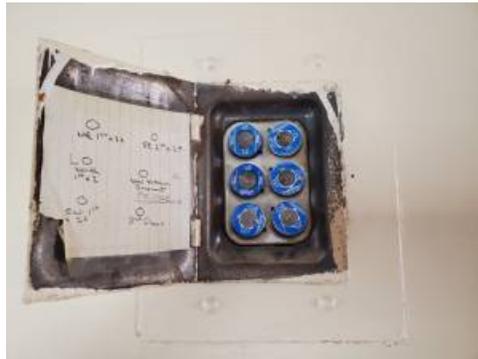
An electrical sub panel is located in the kitchen.

The electrical panel has been painted shut / covered with wall paper. The panel cover could not be removed without the risk of damaging the surrounding wall. No inspection was made of the interior of the main electrical panel. We recommend having the homeowner provide access and call for a re-inspection. A re-inspection fee of \$75 will apply.

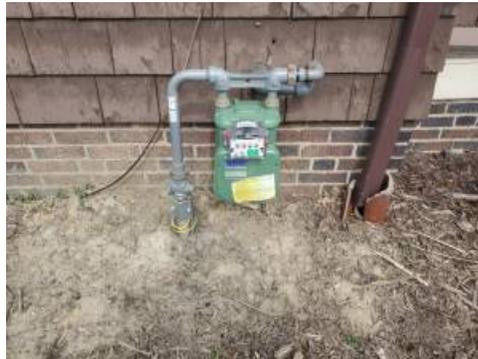
Main fuel shut-off is at the meter located at the exterior of the building.

All gas lines are not visible making it impossible to determine if the lines are bonded and grounded correctly. Have a qualified, licensed person install the correct bonding and grounding to the gas line system.

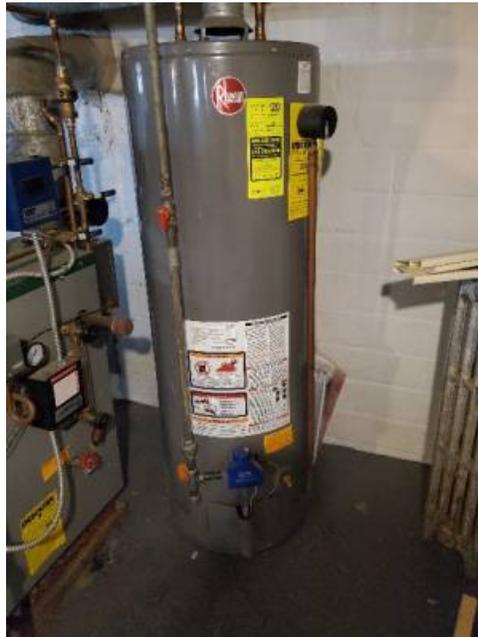
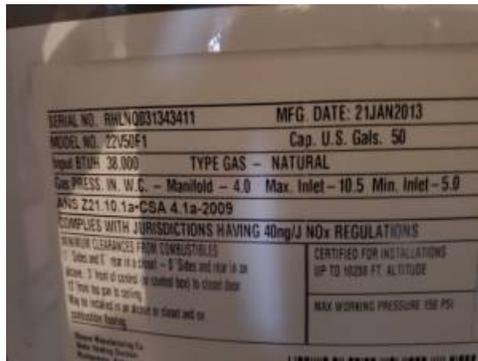
Gas fired water heater.

AGE: Water heater is estimated to be between 3 - 12 years old. Water heaters have a typical life span of 8 - 12 years.

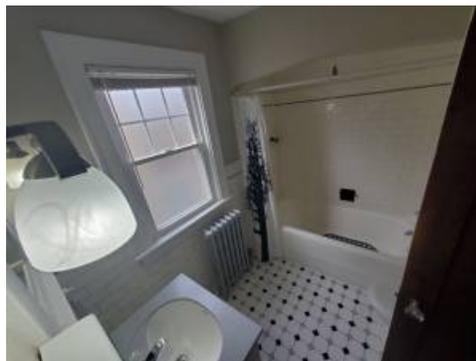
LOCATION: Full bathroom, located in the main hall. Upstairs.

FLOOR: Flooring is covered / partially covered with ceramic tile. The condition of the sub-floor under the finished flooring could not be determined. Typically, when finished bathroom floors are replaced there is some water damage to the subfloor. We recommend budgeting for repairs to the sub-floor when estimating costs for replacing the flooring material.

RECEPTACLES: Ground Fault Circuit Interrupter (GFCI) receptacle(s) were installed without being properly grounded. Many municipalities allow for this type of installation. We recommend consulting with your municipal Building Inspector to determine if correction is needed.
